INSTITUTE REPORT NO. 445

## Field Evaluation of Laser Protective Eyewear

January 1990

LETTERMAN ARMY INSTITUTE OF RESEARCH PRESIDIO OF SAN FRANCISCO CALIFORNIA 94129

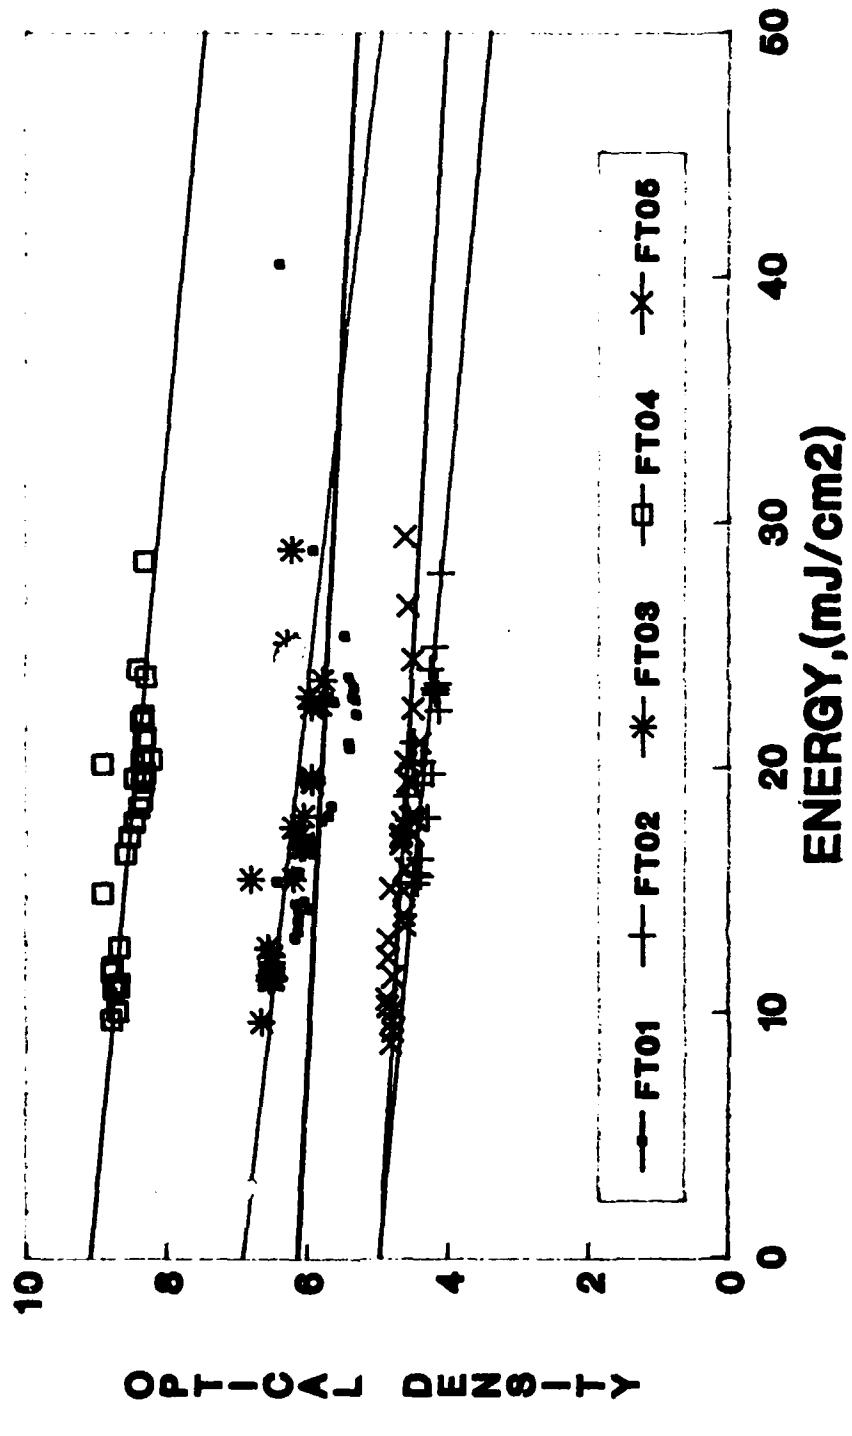
APP C -- Figure 1

Samples of severely scratched B-LPS were retrieved from NTC and examined in our laboratory. Only the B-LPS that were most severely damaged were used, so the measurements reported here are a "worst-case" analysis.

Two measurements were performed in our laboratory. First, a scratched laser frontsert was evaluated for retention of laser protective characteristics. Figure 1 shows the optical density of scratched frontserts as a function of the amount of Lambda 2 laser energy to which they were exposed. All of the frontserts tested retained sufficient density at the design wavelength to meet specifications, despite the damage they had suffered.

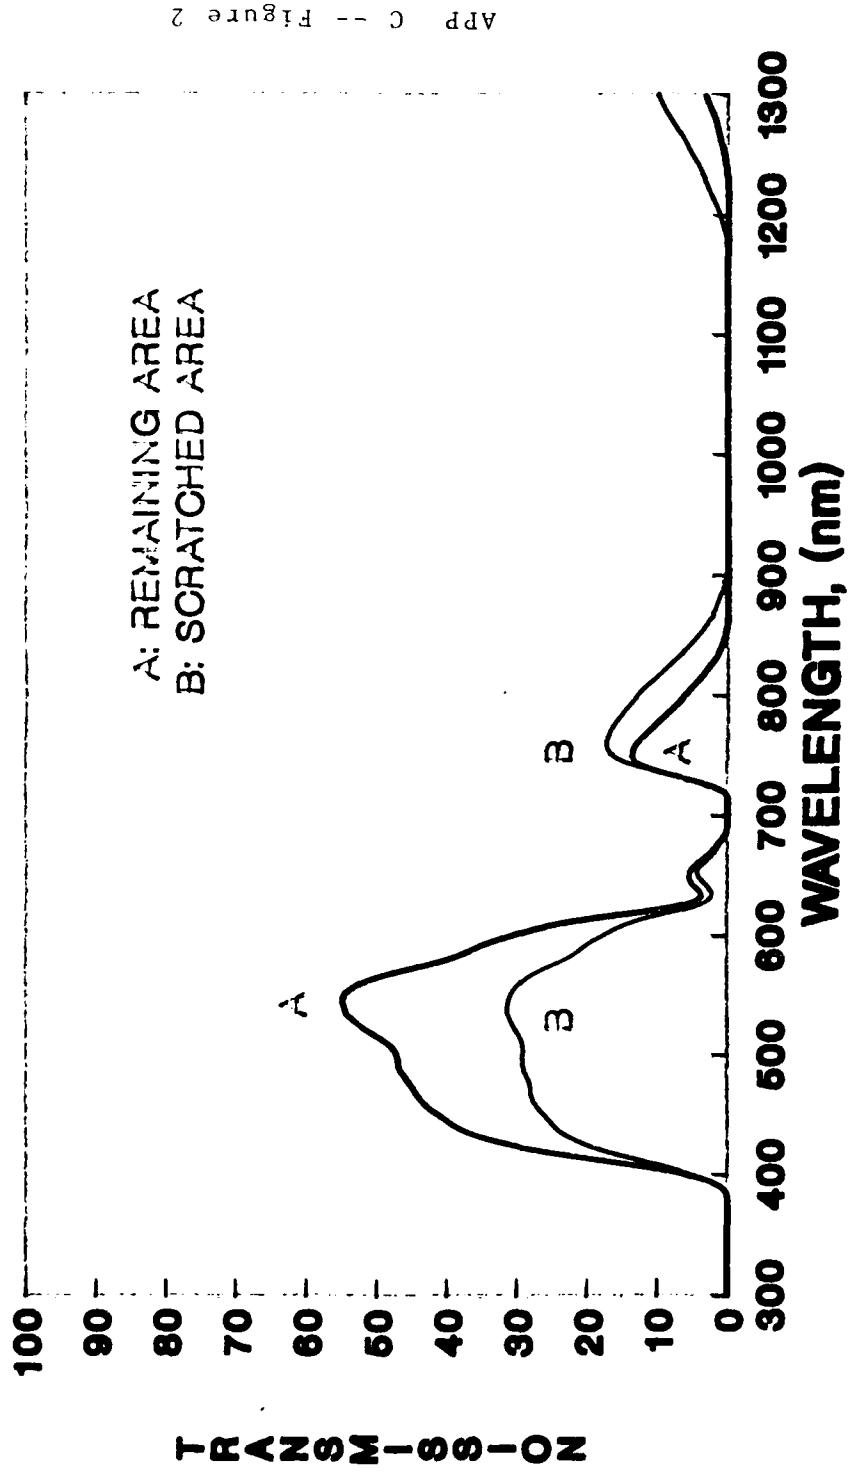
# FIELD TESTED FRONT INSERTS 2 LAMBDA

The second test we used measured luminous transmission as a function of wavelength from 300-1300 nm. The frontserts showed a decrease in transmission over the visible spectrum in the scratched area. (See Figure 2) This is apparently due to the reflection and refraction caused by the surface scratches. There was an increase in transmission in the infrared portion of the laser frontsert luminous efficiency function, perhaps caused by loss of the laser protective coating in the scratched areas.

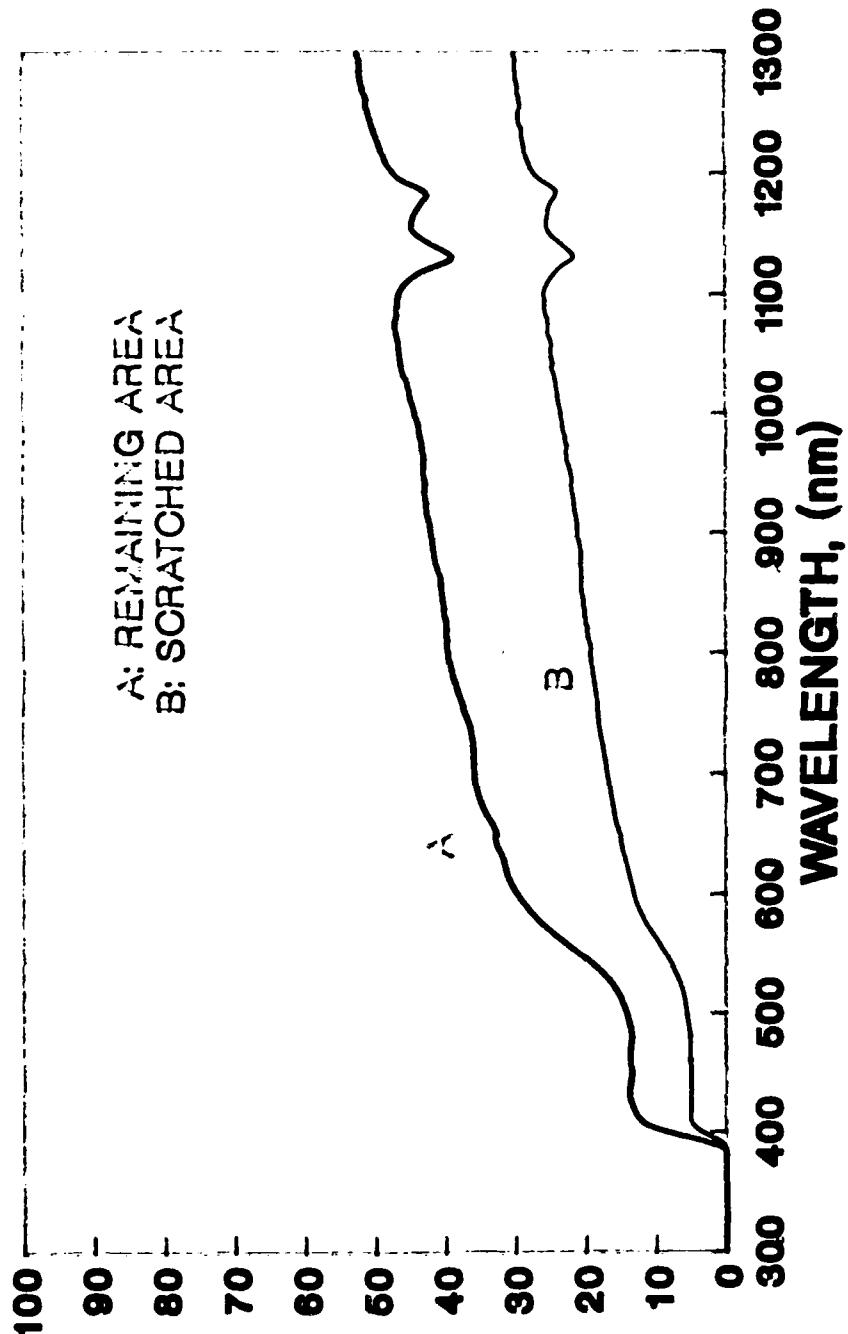
APP C -- FIGURE 3

The tinted B-LPS, which have no laser protective coating, showed a general decrease in transmission throughout the 300-1300 nm region in the scratched areas. (See Figure 3) This result is similar to that observed for clear (untinted) B-LPS.
